Checking of Glulam Beams

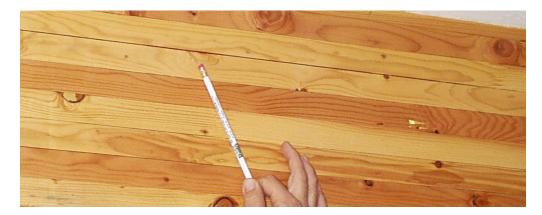
In glulam beams, checking most often occurs along gluelines. Each lamination can have slightly different moisture contents; once the beam dries, these differences cause stress concentrations at or near lamination boundaries (gluelines). Checking does not typically affect the beam strength capacity since the wood fibers are only being separated, not fractured. Checking along a glueline (see photo below) is sometimes mistaken as a delamination. Some glue maybe visible in the check openings but usually will have a "patchy" appearance, not a glossy look that is associated with insufficient glue adhesion.

Checking along gluelines is usually most evident along the first lamination from the bottom edge. In exposed applications, the bottom lamination dries quicker than the rest of the beam since it is exposed to heat on three sides. Thus, stress builds up along the glueline and checking occurs. Though visually the "separation" of the tension lamination may be alarming, checking at this first lamination has minimal affects on the beam's strength.
