Lateral Bracing of Joists and Beams

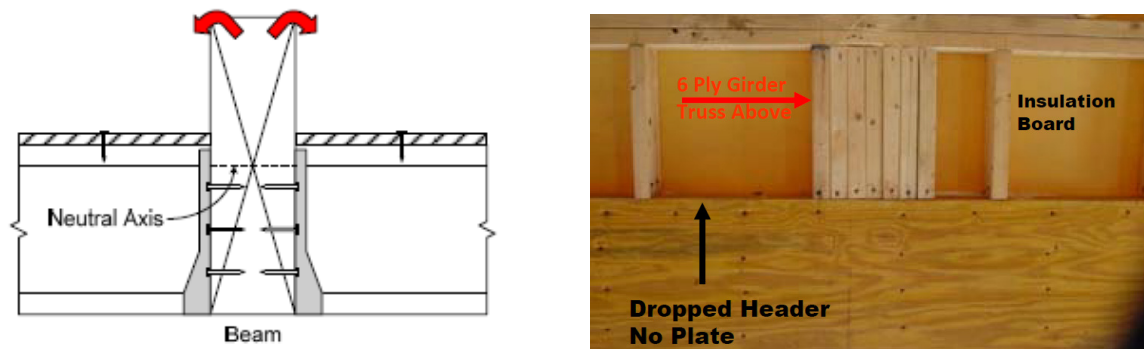
Figure 4: Examples of Improper Lateral Bracing

The following are examples of conditions that are not considered properly braced. Improperly braced applications should not be sized with either BC Calc or Boise Cascade EWP literature. For further information regarding beam bracing, see the Wood I-Joist Manufacturers Association (WIJMA) *Dropped Header Design Guide* at <http://i-joist.org/policies-publications>.

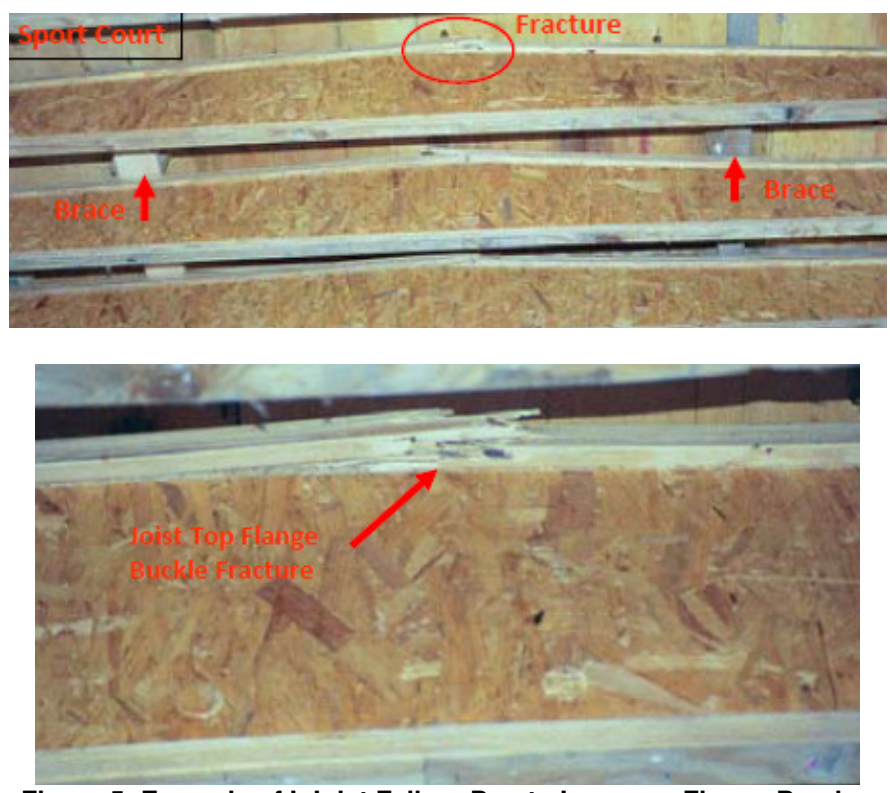
Figure 5: Example of I-Joist Failure Due to Improper Flange Bracing

Failures may occur due to improper joist/beam bracing. As shown in Figure 5, top flange buckling is likely when bracing is inadequate.

Ceiling/attic joists are typically not sheathed in residential construction. When installing BCI[®] / AJS[®] joists in this application, the top flanges shall be laterally braced. In lieu of sheathing, 1x4 bracing can be installed perpendicular to the joists and attached with (2) 8d nails into each flange. This bracing shall be installed at 24" on-center along the length of the joist. With bracing installed, joists may be sized utilizing BC Calc or the allowable floor PLF tables shown in Boise Cascade literature. An exception to this bracing schedule is the prescriptive ceiling joist design shown on page 13 of the Boise Cascade EWP Specifier Guides.

Bracing is a critical element of each joist and beam application. If sheathing is not directly attached to the top edge of the member, the project's design professional of record shall consider other bracing options. Failure to correctly store, use, or install VERSA-LAM[®], Boise Glulam[®], ALLJOIST[®], and BCI[®] Joist in accordance with Boise Cascade EWP product literature will void the limited warranty. For further questions, please feel free to contact Boise Cascade EWP Engineering at 800.232.0788.
