Lateral Bracing of Joists and Beams

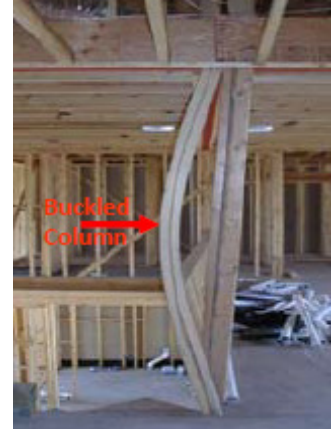
Figure 1: Column Buckling

Bracing is a critical item of all structural components. A lack of bracing is can be very apparent in column and stud applications, as shown in Figure 1. Axial loads create compression stress in the member. Without proper bracing, buckling causes excessive displacement and possible structural failure.

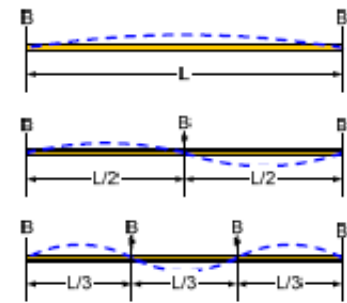
Figure 2: Top Edge Buckling of Joists and Beams

Bracing of joists and beams is as important, though may not be as apparent. When a joist or beam is loaded, compression and tension forces develop within the product. For simple span applications, the top flange of I-joists and top edge sections of beams are subjected to compression stress. As with vertical products, these compression forces can cause buckling if the top edge is not braced laterally (see Figure 2). Improper or absence of bracing significantly reduces the load-carrying capacity of the joist or beam.
