Checking of Glulam Beams

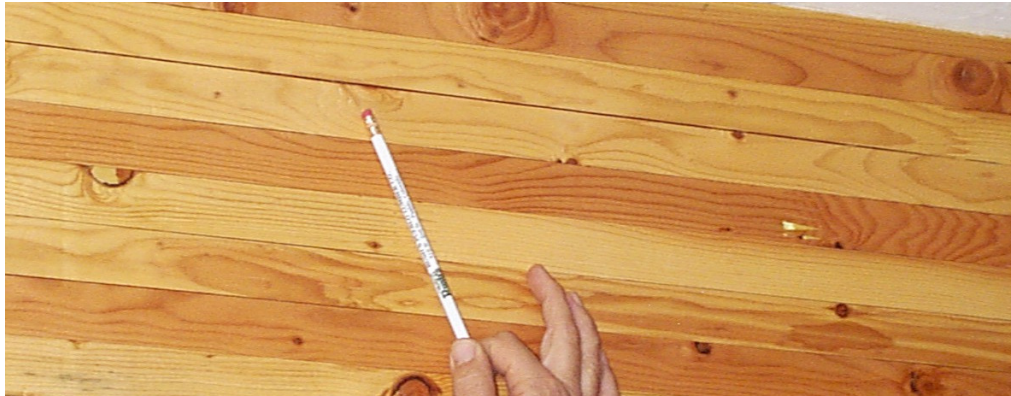
In glulam beams, checking most often occurs along gluelines. Each lamination can have slightly different moisture contents; once the beam dries, these differences cause stress concentrations at or near lamination boundaries (gluelines). Checking does not typically affect the beam strength capacity since the wood fibers are only being separated, not fractured. Checking along a glueline (see photo below) is sometimes mistaken as a delamination. Some glue maybe visible in the check openings but usually will have a “patchy” appearance, not a glossy look that is associated with insufficient glue adhesion.

Checking along gluelines is usually most evident along the first lamination from the bottom edge. In exposed applications, the bottom lamination dries quicker than the rest of the beam since it is exposed to heat on three sides. Thus, stress builds up along the glueline and checking occurs. Though visually the “separation” of the tension lamination may be alarming, checking at this first lamination has minimal affects on the beam’s strength.

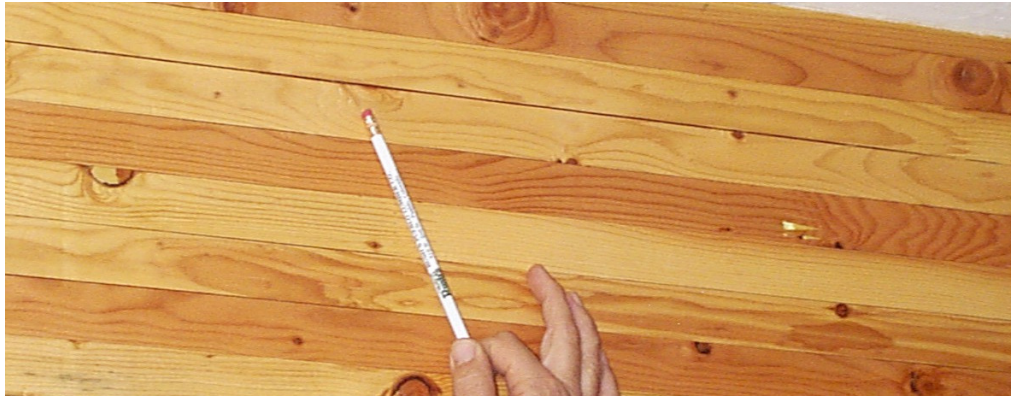
In glulam beams, checking most often occurs along gluelines. Each lamination can have slightly different moisture contents; once the beam dries, these differences cause stress concentrations at or near lamination boundaries (gluelines). Checking does not typically affect the beam strength capacity since the wood fibers are only being separated, not fractured. Checking along a glueline (see photo below) is sometimes mistaken as a delamination. Some glue maybe visible in the check openings but usually will have a “patchy” appearance, not a glossy look that is associated with insufficient glue adhesion.

Checking along gluelines is usually most evident along the first lamination from the bottom edge. In exposed applications, the bottom lamination dries quicker than the rest of the beam since it is exposed to heat on three sides. Thus, stress builds up along the glueline and checking occurs. Though visually the “separation” of the tension lamination may be alarming, checking at this first lamination has minimal affects on the beam’s strength.
